**Flood Control Project Maintenance
Levee Inspections**

2010 Channel Summary Report

Placer County

Truckee River

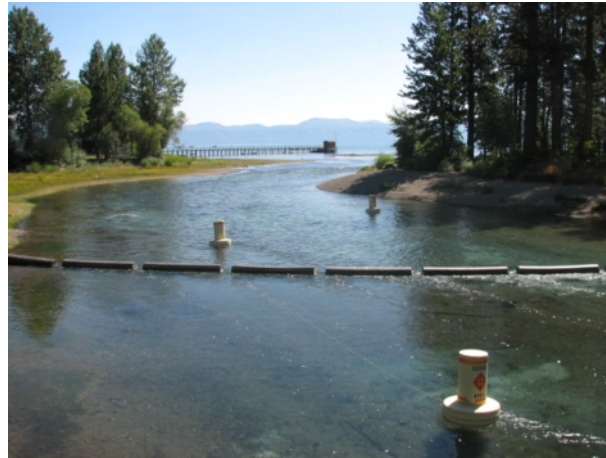
Levee Mile Report Line	1
Start Levee Mile	0.00
End Levee Mile	0.00
Location	
Category	Channels
Item	Vegetation & Obstructions
View is looking towards Lake Tahoe from outlet structure.	
johngw_c_20100809_097.jpg

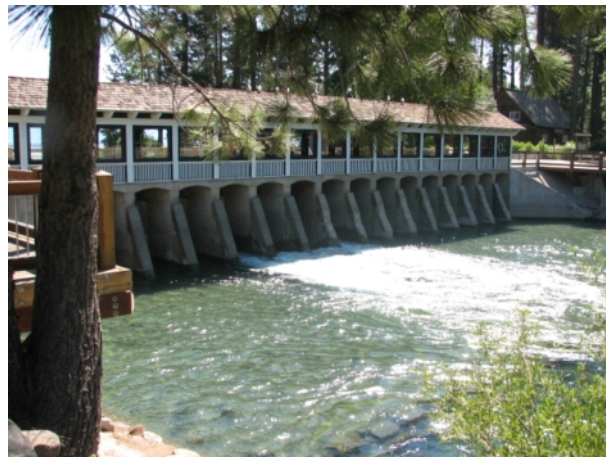
Levee Mile Report Line	11
Start Levee Mile	0.00
End Levee Mile	0.00
Location	
Category	Channels
Item	Vegetation & Obstructions
View is from Hwy. 89 looking upstream at outlet structure out flow.	
johngw_c_20100809_098.jpg

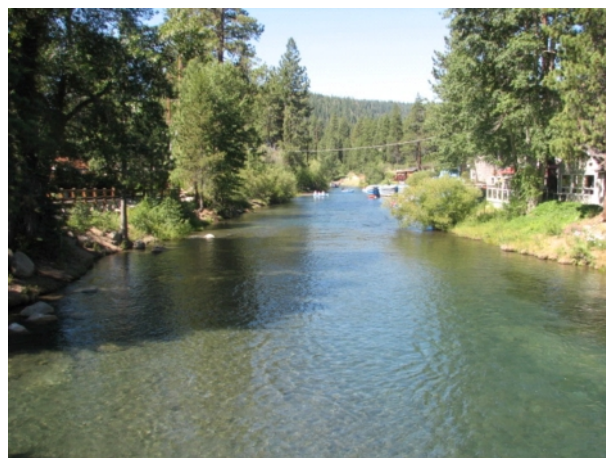
Levee Mile Report Line	16
Start Levee Mile	0.00
End Levee Mile	0.00
Location	
Category	Channels
Item	Vegetation & Obstructions
View looking downstream from Hwy 89.	
johngw_c_20100809_099.jpg

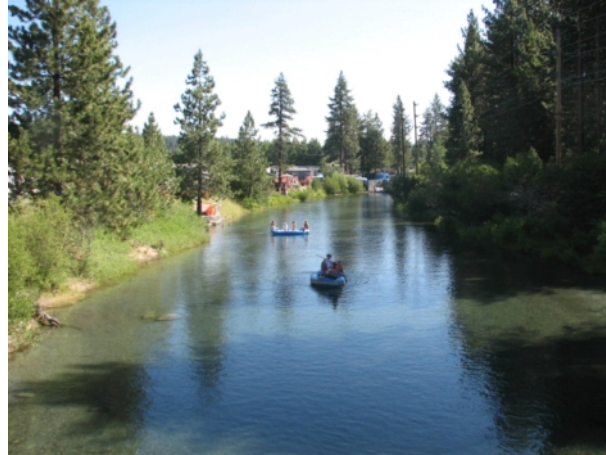
Levee Mile Report Line	21
Start Levee Mile	0.00
End Levee Mile	0.00
Location	
Category	Channels
Item	Vegetation & Obstructions
View looking upstream from walking bridge.	
johnngw_c_20100809_100.jpg

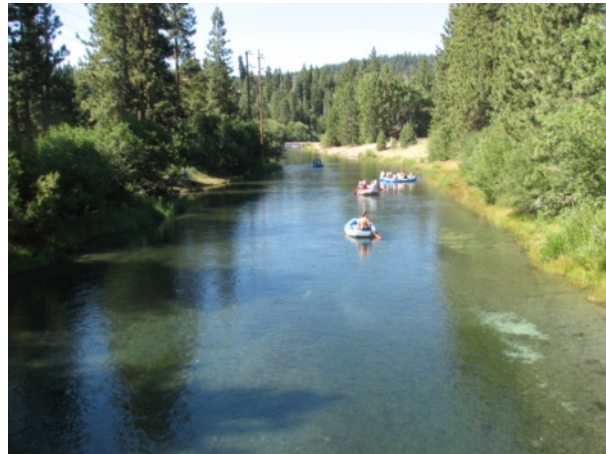
Levee Mile Report Line	26
Start Levee Mile	0.00
End Levee Mile	0.00
Location	
Category	Channels
Item	Vegetation & Obstructions
View looking downstream from walking bridge.	
johnngw_c_20100809_101.jpg

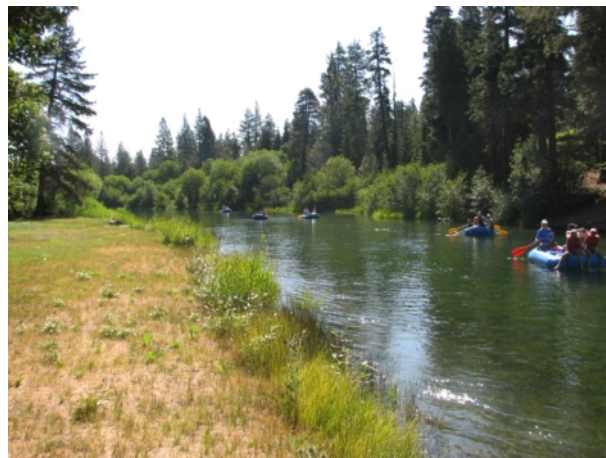
Levee Mile Report Line	31
Start Levee Mile	0.00
End Levee Mile	0.00
Location	
Category	Channels
Item	Vegetation & Obstructions
View is from the east end of lumber yard looking upstream.	
johnngw_c_20100809_102.jpg

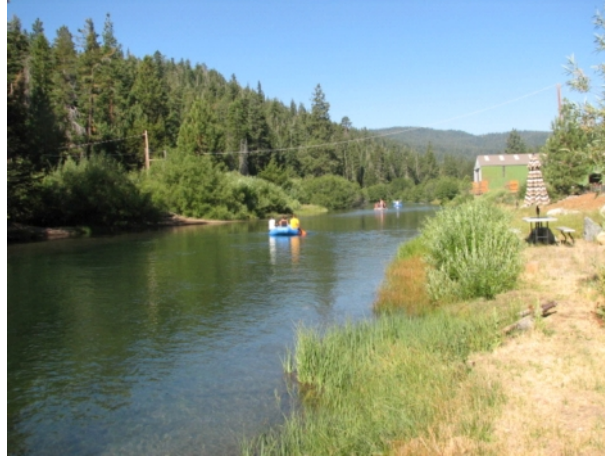
Levee Mile Report Line	36
Start Levee Mile	0.00
End Levee Mile	0.00
Location	
Category	Channels
Item	Vegetation & Obstructions
View looking downstream at lumber yard's east end.	
johnngw_c_20100809_103.jpg
